Emergency Medicine and Trauma Care Journal

Case Report

Myocardial Perforation Resulting from Implanted Pacemaker Lead

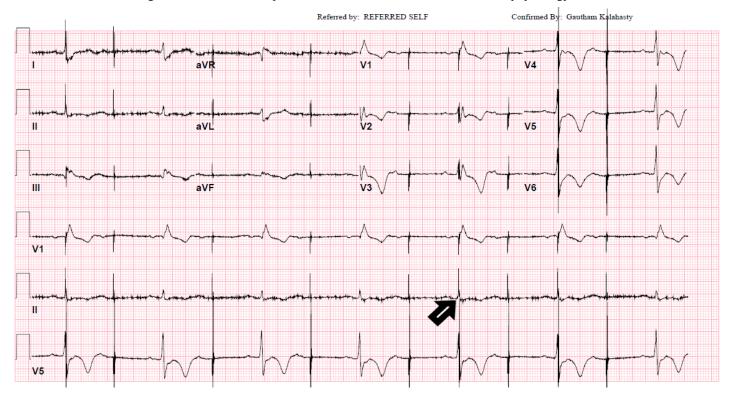
Figure 1: Electrocardiogram showing start of capture.

In the emergency department an Electrocardiogram (ECG) showed regular sinus rhythm, bradycardia with heart rate decreased to the 30s, and consistent pacer spikes evident, but not consistently triggering a QRS complex. Pacemaker interrogation in the emergency department found his device to be intermittently pacing with an interval capture. Device voltage was increased, which did not result in increasing capture rate see Figure 1. A bedside echo showed a dual chamber device with two visible leads, with the right ventricular lead appearing to terminate beyond the plane of the right ventricular apex, potentially perforating the right ventricle wall see Figure 2. Confirmatory Computed tomography (CT) scan of the chest with contrast revealed a left-sided two lead pacemaker device with one lead terminating in the right atrial appendage, and the second terminating past the right ventricular apical myocardium, with a trace cardiac effusion see Figure 3. The patient was subsequently admitted to the cardiac intensive

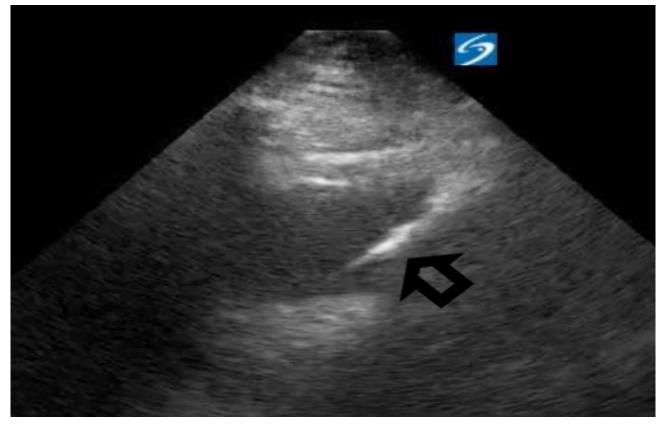
Figure 2: Ultrasound showing perforation of wire into right ventricle.
